# Building Efficiency at the Balcony

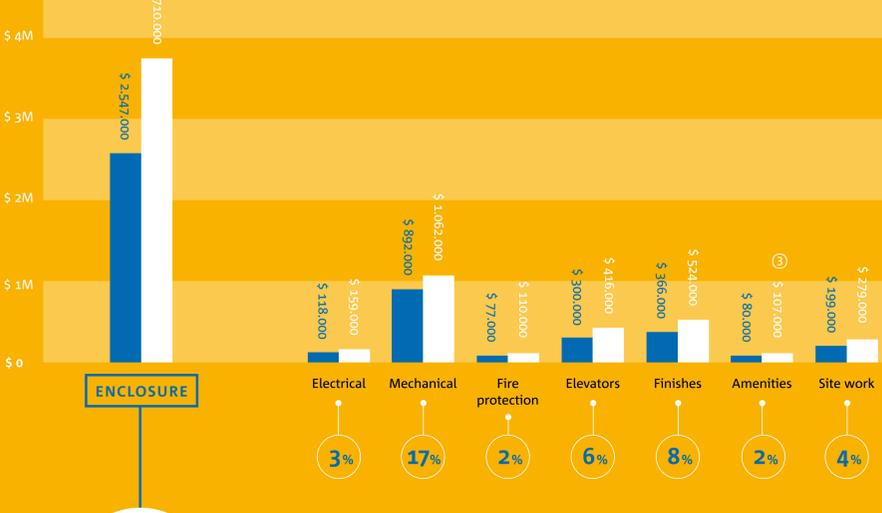
DISTRIBUTION OF THE 30-YEAR CAPITAL LOAD, BY SYSTEM, WITHIN A SINGLE BUILDING

● Current Value ● Future Value

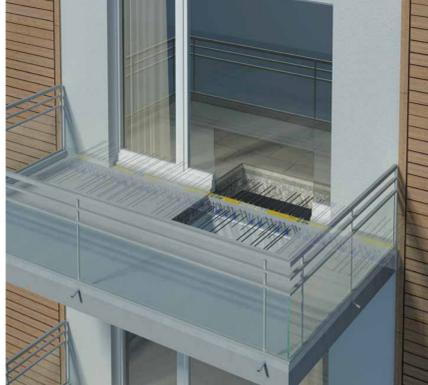
Placement of concrete structural thermal breaks at the balcony window.

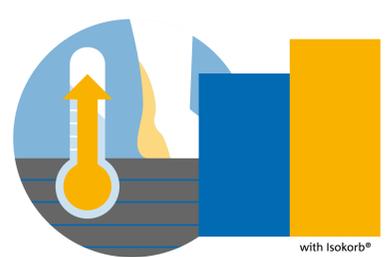
Structural thermal breaks can increase surface temperatures by up to

**13°F / 7°C**

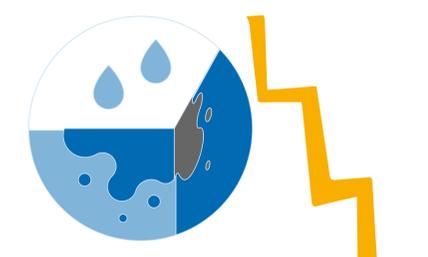
The risk of mold growth is reduced with structural thermal breaks.

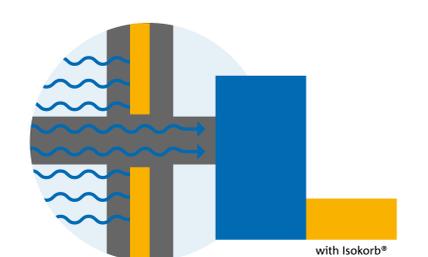
Compared to a conventional continuous balcony, structural thermal breaks cut heat flow through and around the slab by

**75%**
